DOE ID NO. GJ-44367-CC (PHASE F)

RADIOLOGICAL ASSESSMENT FOR

DENVER & RIO GRANDE WESTERN RAILROAD

Revised: August 23, 1991

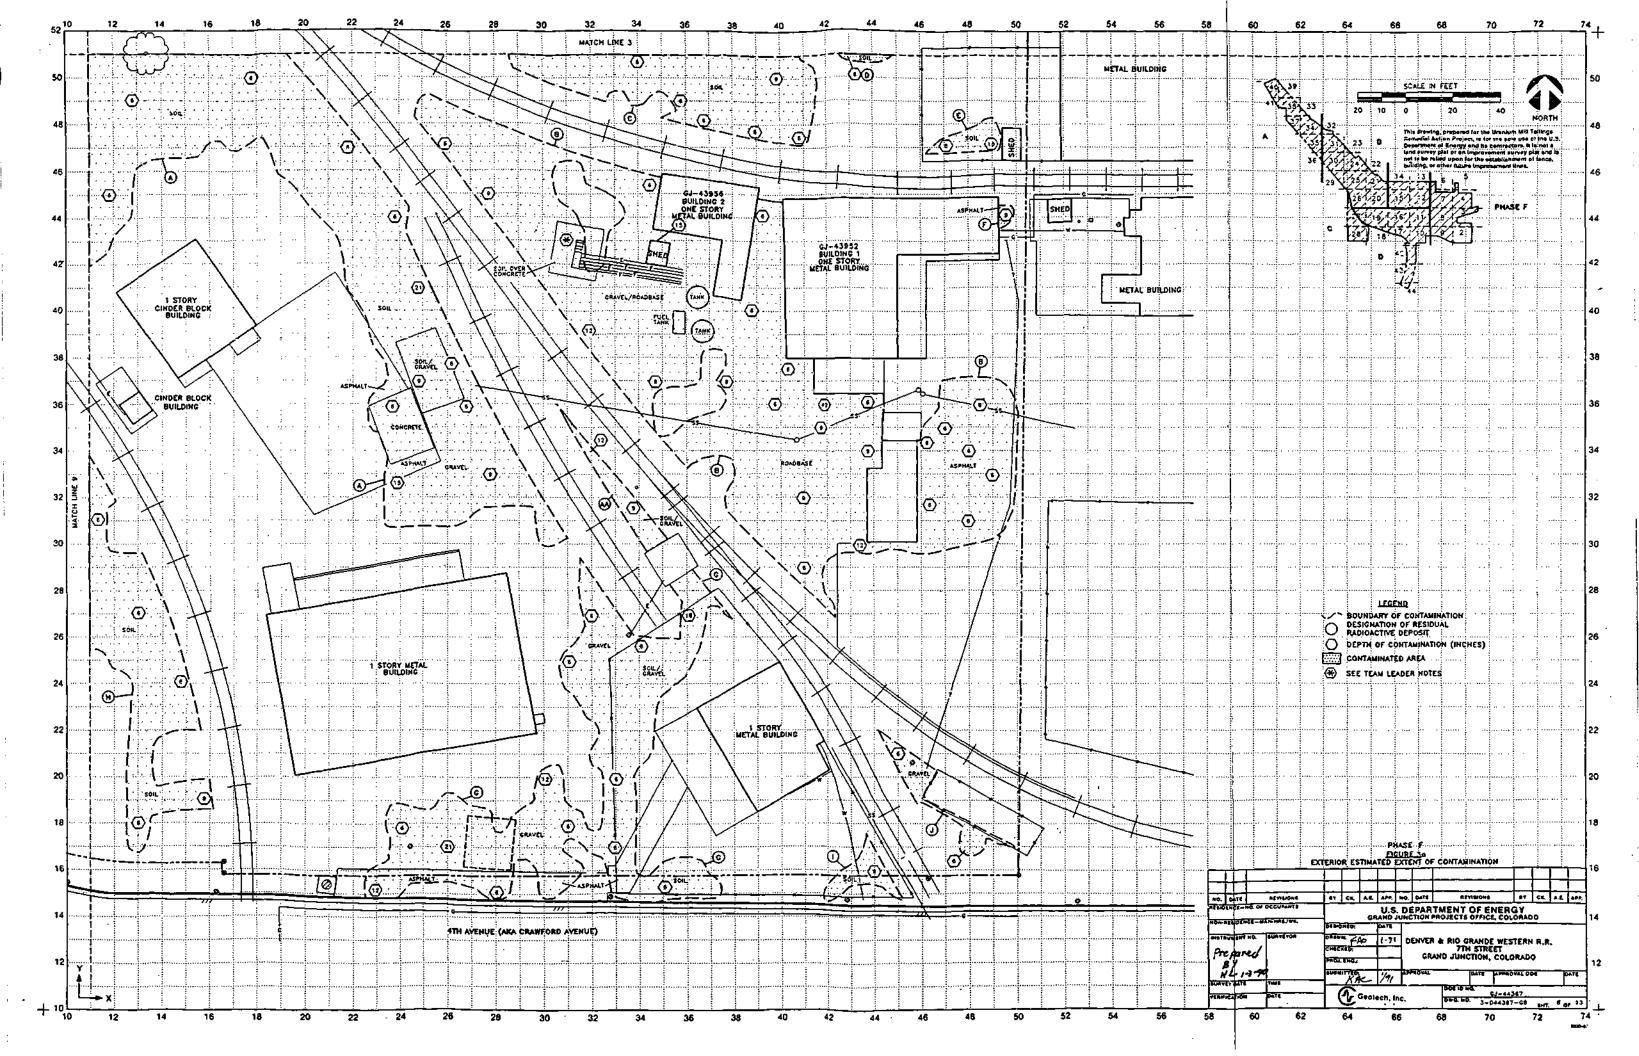
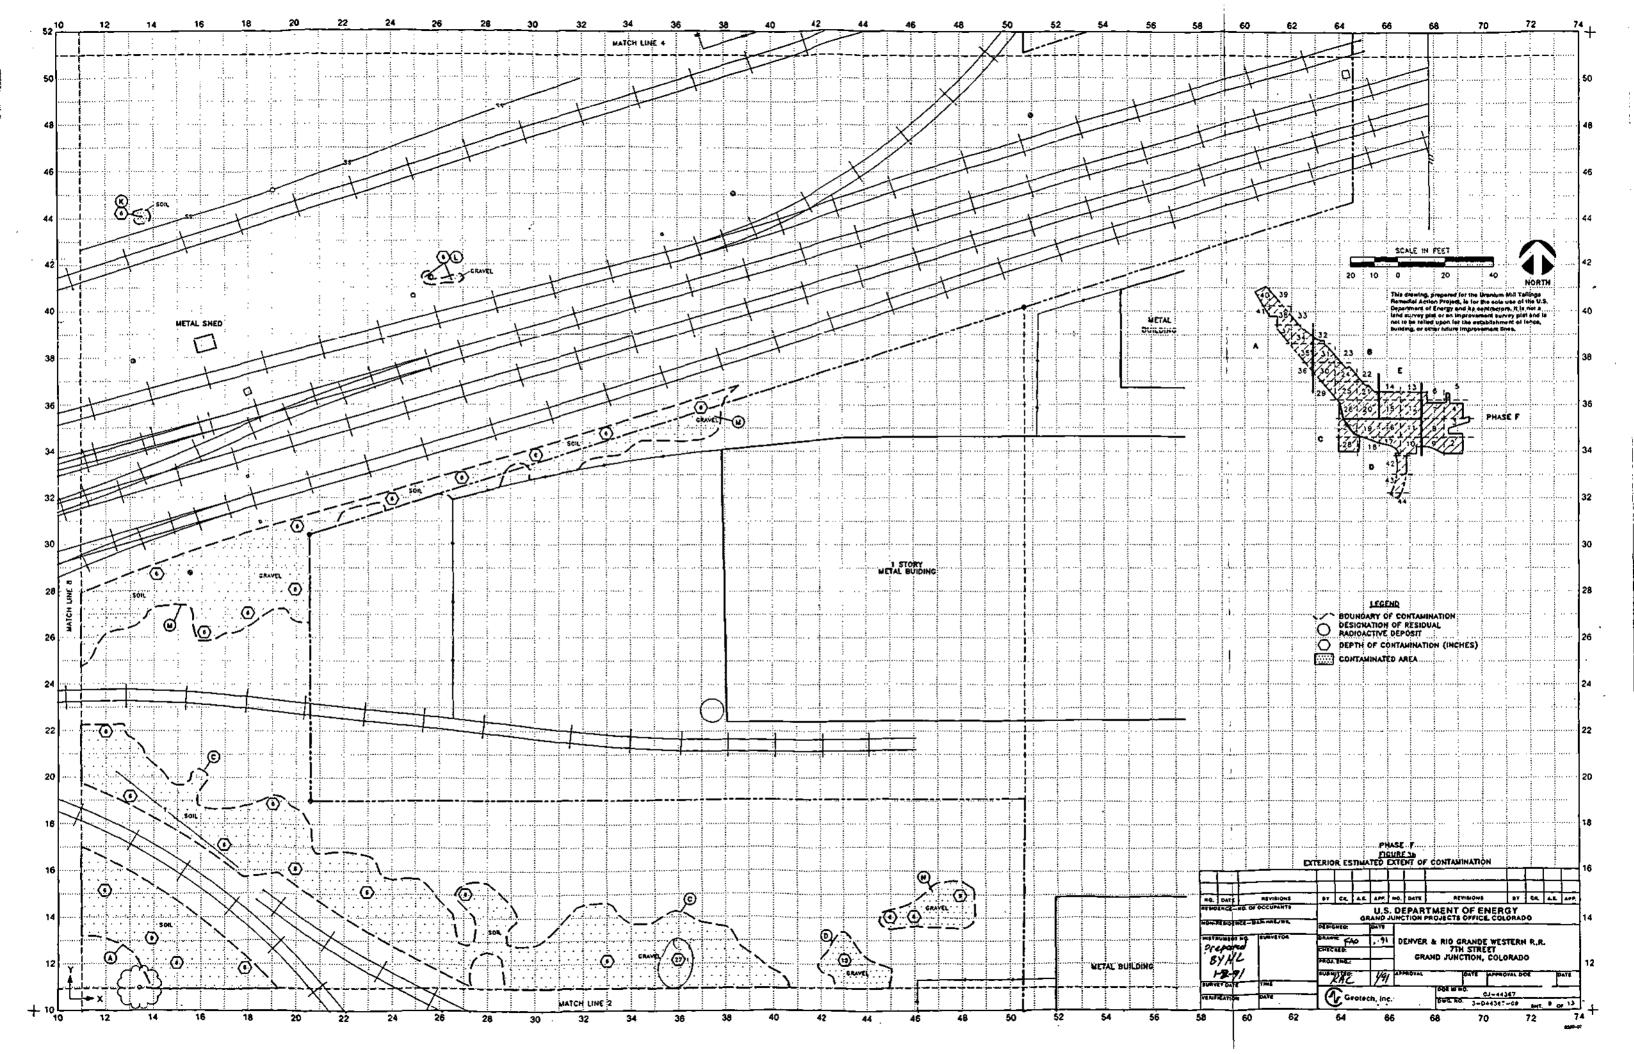
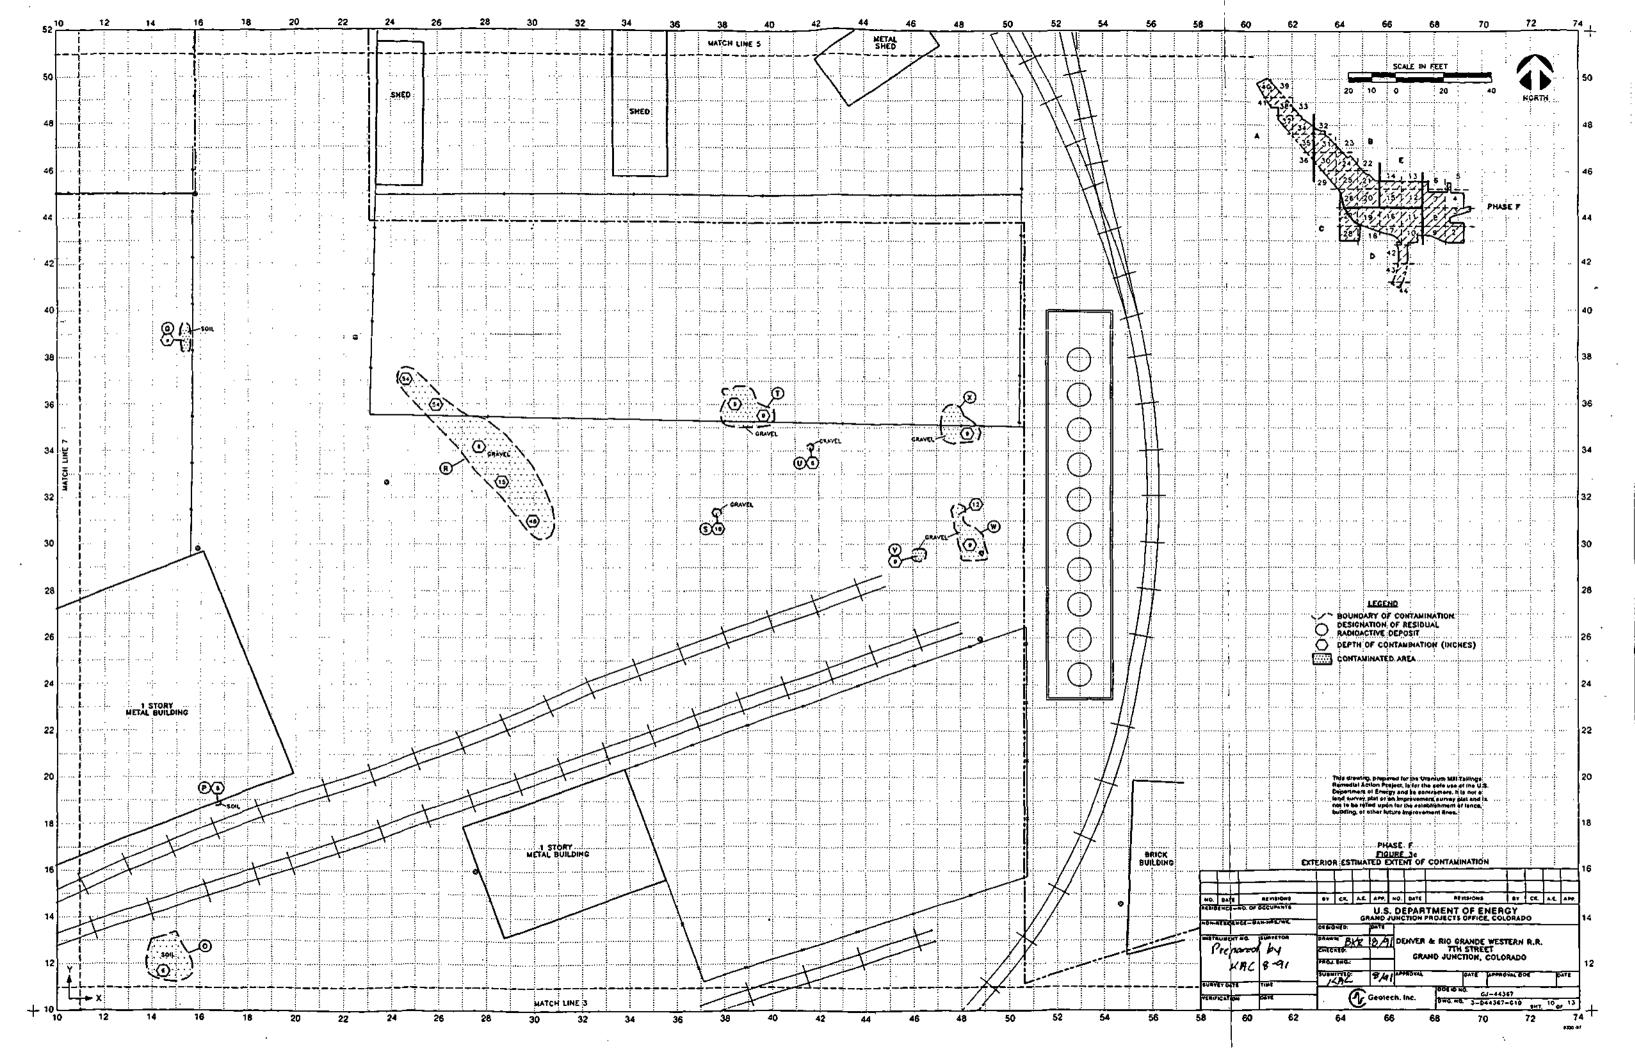
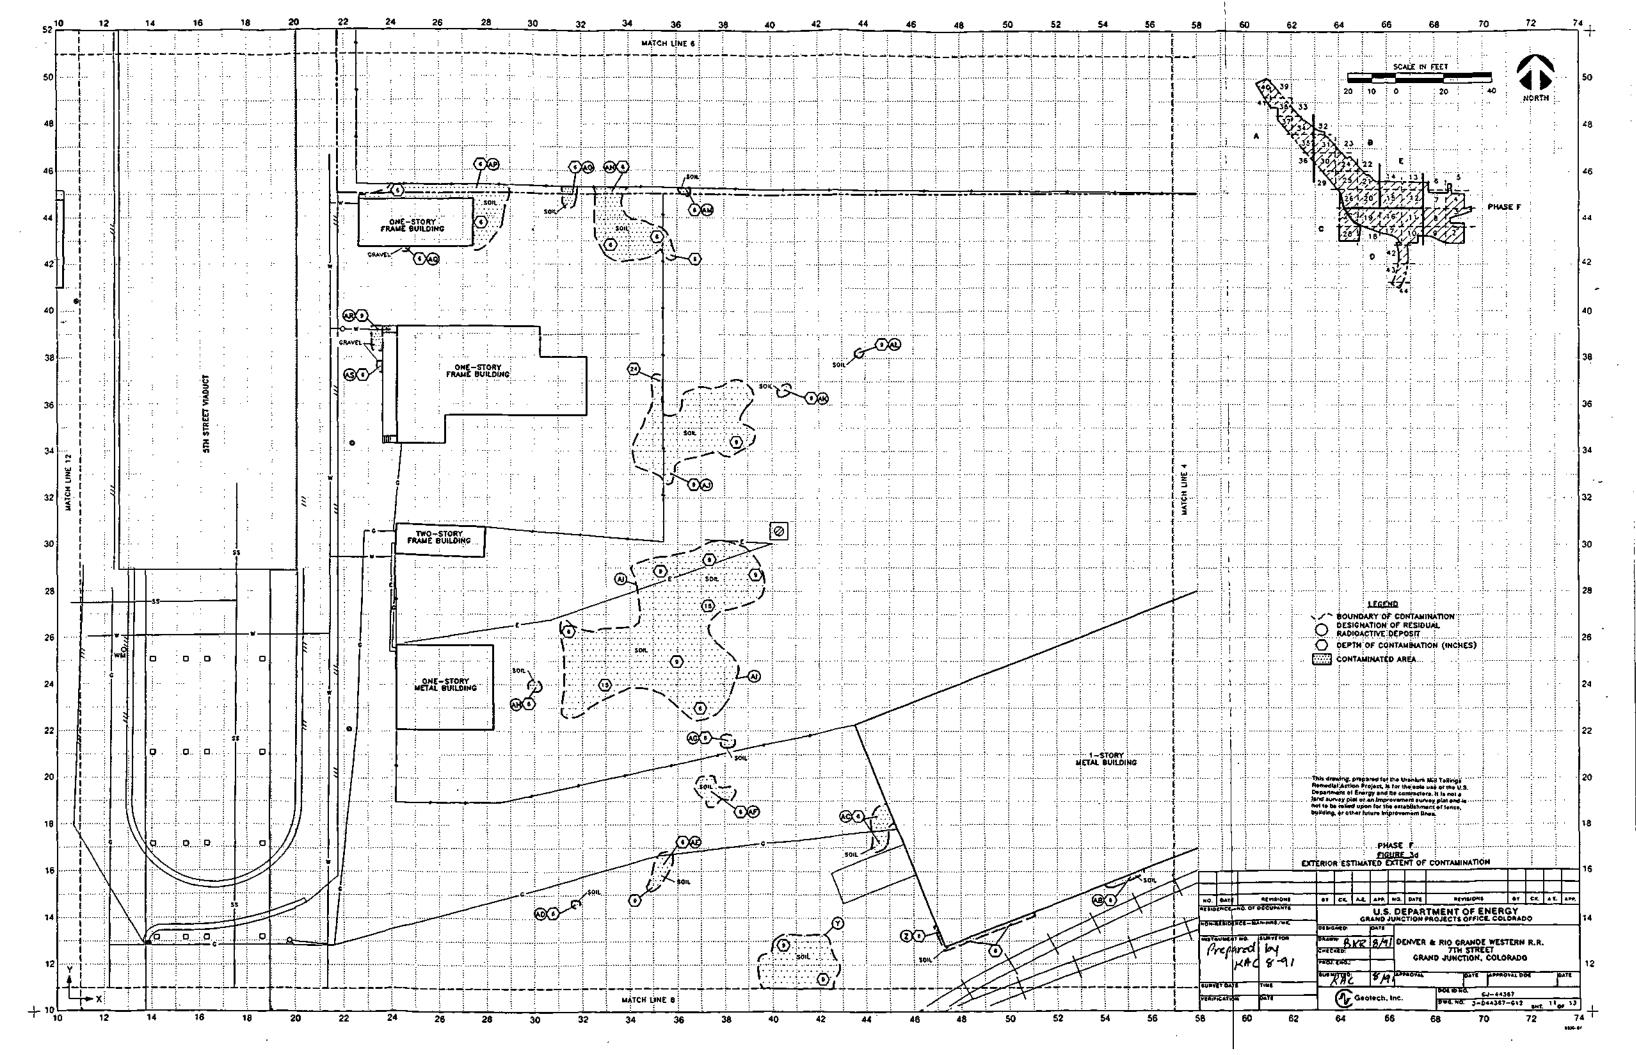
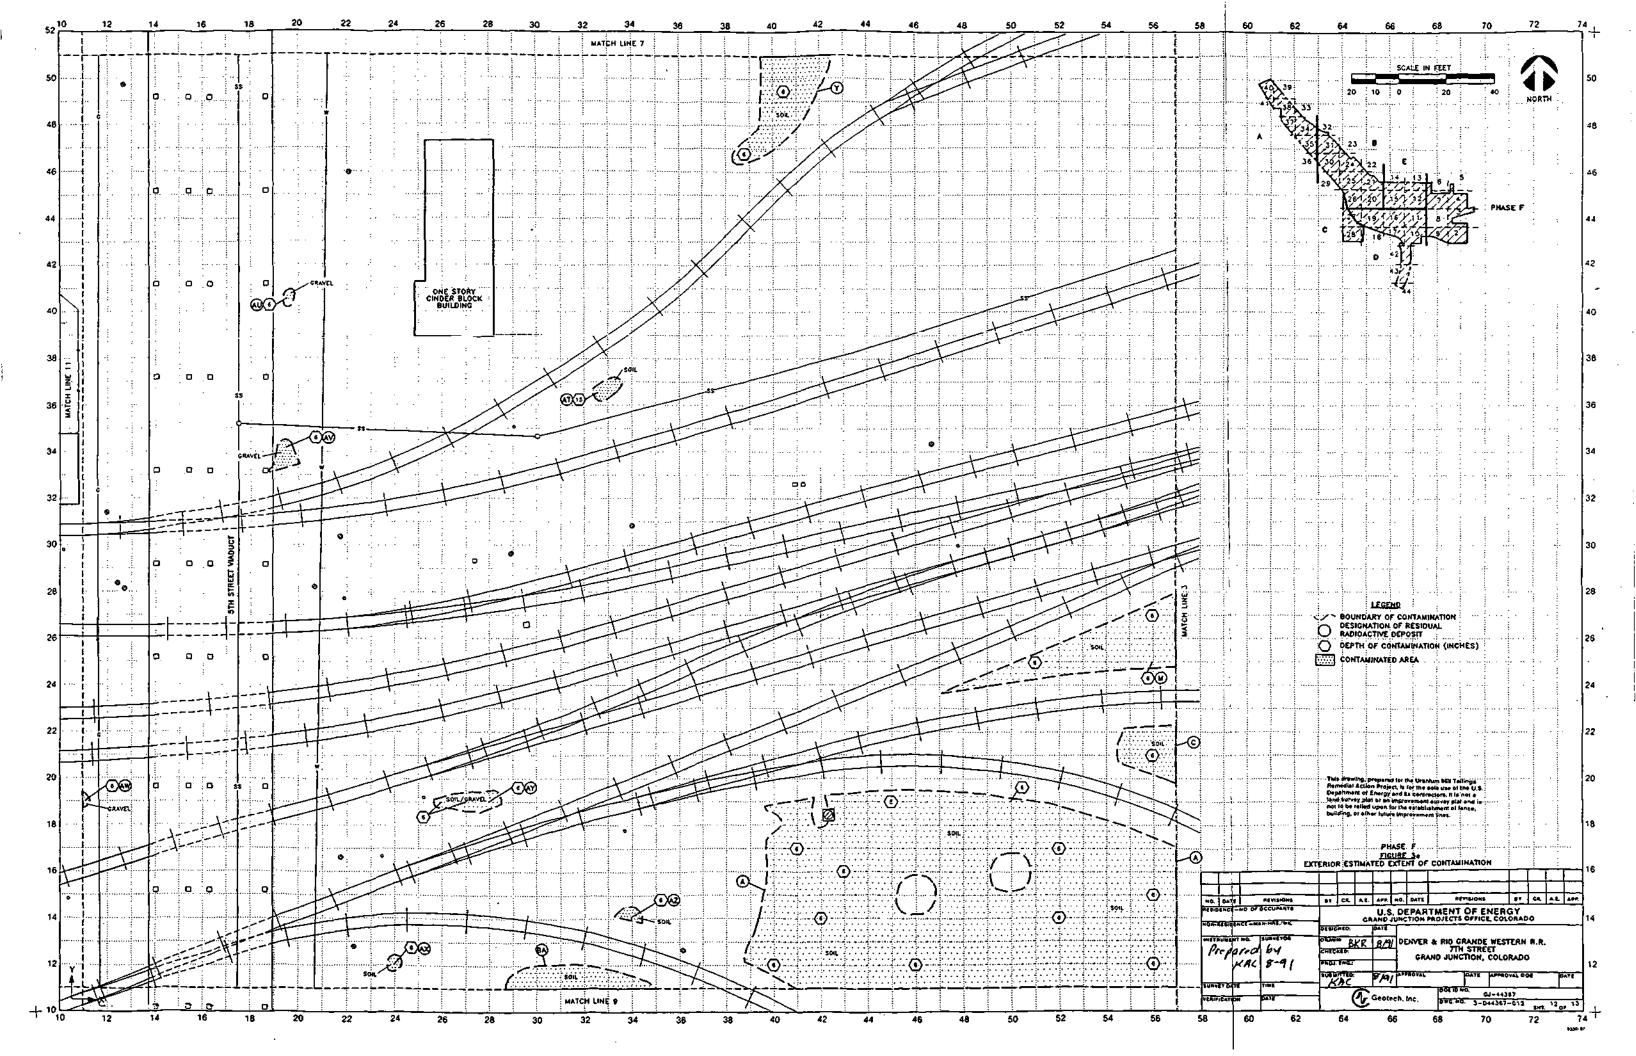
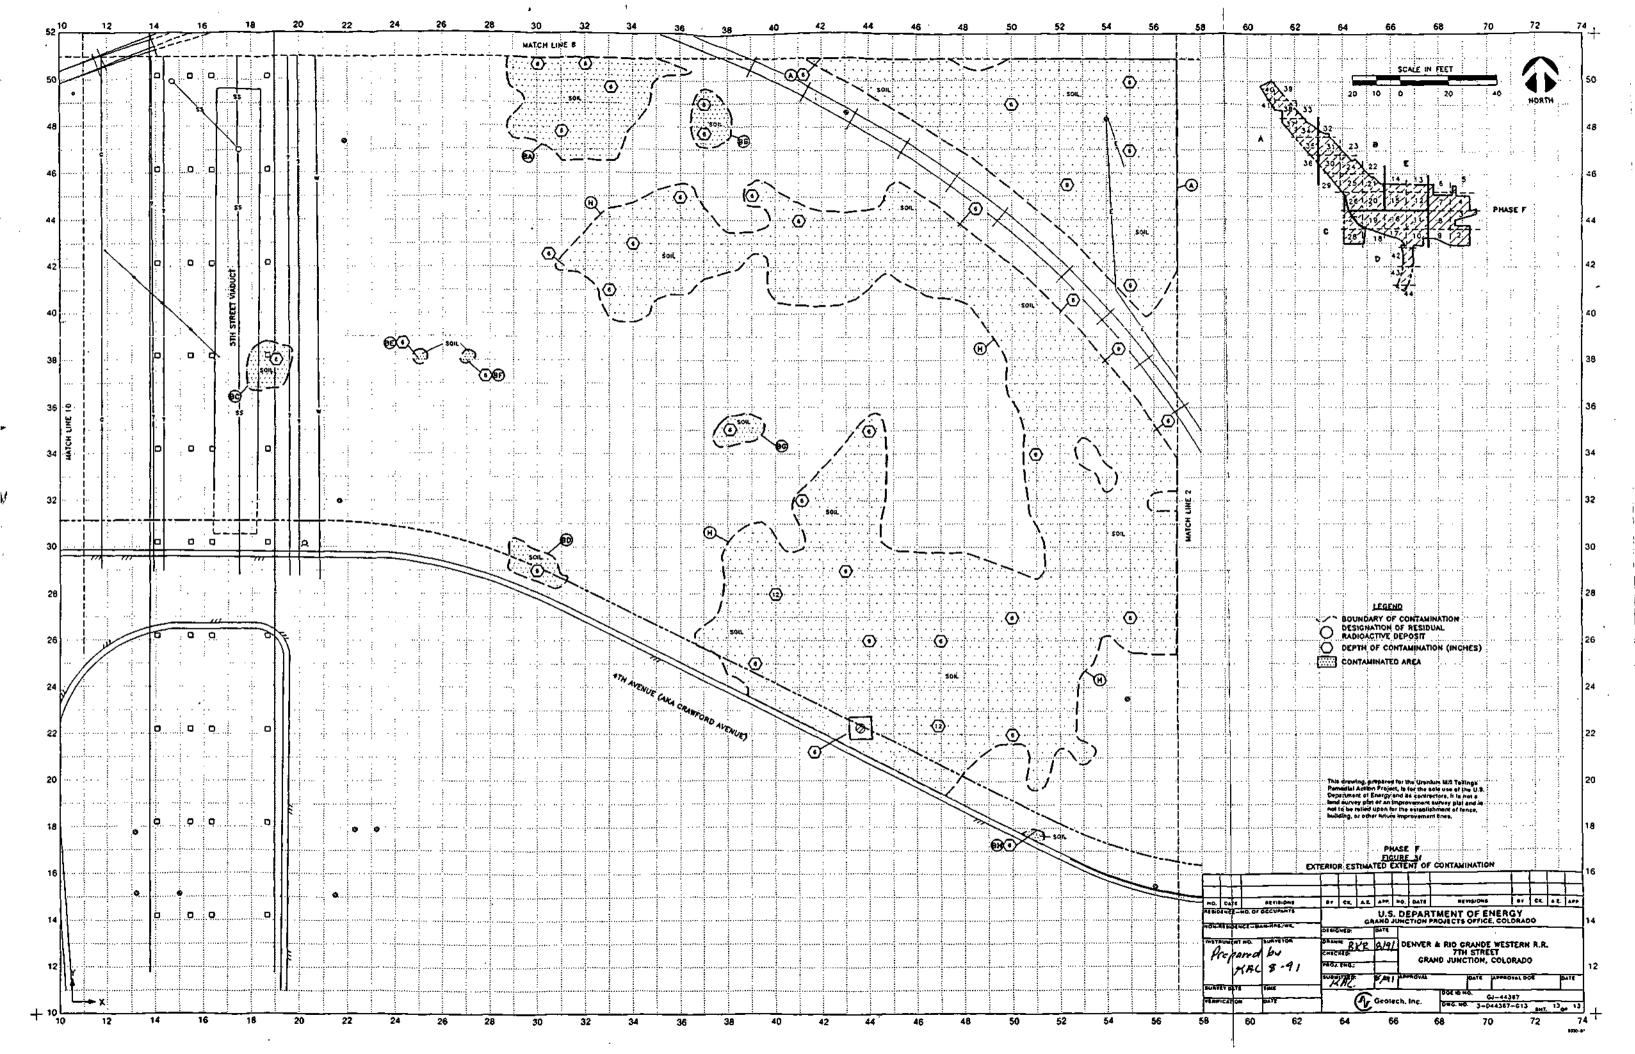
Figures 2a through 2f. Gamma Exposure Rates/Sample Locations Figures 3a through 3f. Exterior Estimated Extent of Contamination

Exterior Deposits A through BH (Figures 3a through 3f) should be removed and the appropriate cover material replaced.

The foundation of the one-story metal building (Figures 3c and 3d) was investigated for contaminated concrete. Data collected indicate no contamination involving the concrete

foundation. Tailings from adjacent exterior deposits (Deposit P [Figure 3c], Deposit Z [Figure 3d], and Deposits AB and AC [Figure 3d]) do not extend beneath the footing of the metal building.
